CT90K5

COMPARISON OF CT90K5 TO CT90K4

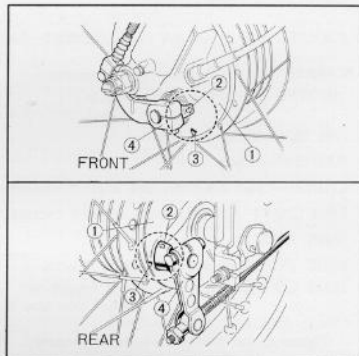
On the CT90K5, new wear indicators were provided in the front and rear brakes. When the brake applied, an arrow, adjacent to the brake arm, moves toward a reference mark on the brake panel. The distance between the arrow and the reference mark, on full application of the brake, indicates brake lining thickness.

Fig. K5.1 ① Brake panel ② Arrow
③ Reference mark ④ Brake
