COOLING SYSTEM

WATER PUMP

MECHANICAL SEAL INSPECTION

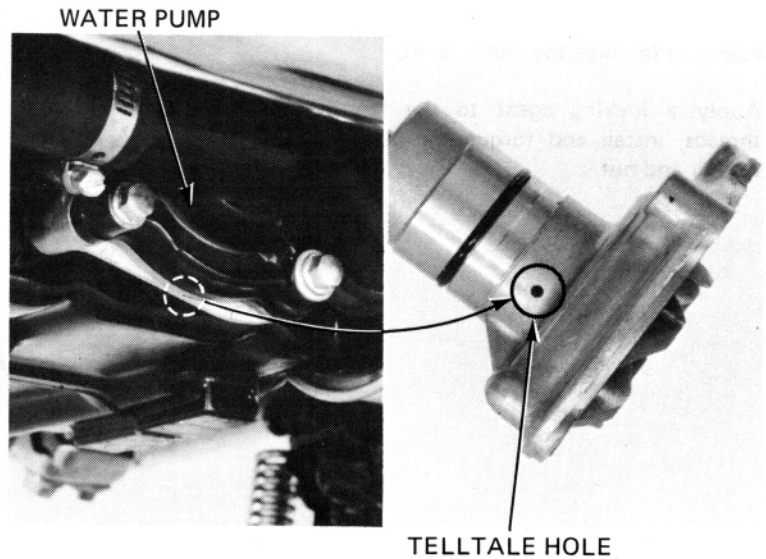
Remove the crankcase left rear cover.
Inspect the telltale hole for signs of mechanical seal coolant leakage.
Replace the water pump as an assembly if the mechanical seal is leaking.

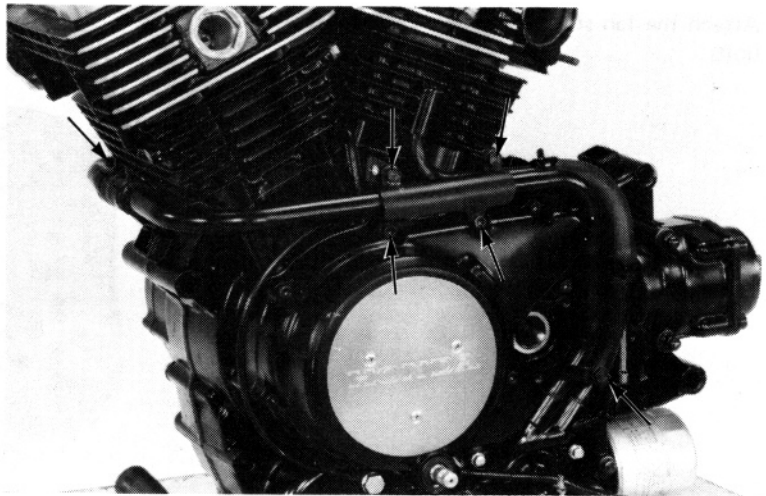
Remove the engine from the frame (Section 5).
Remove the water pipes and hoses from the engine.

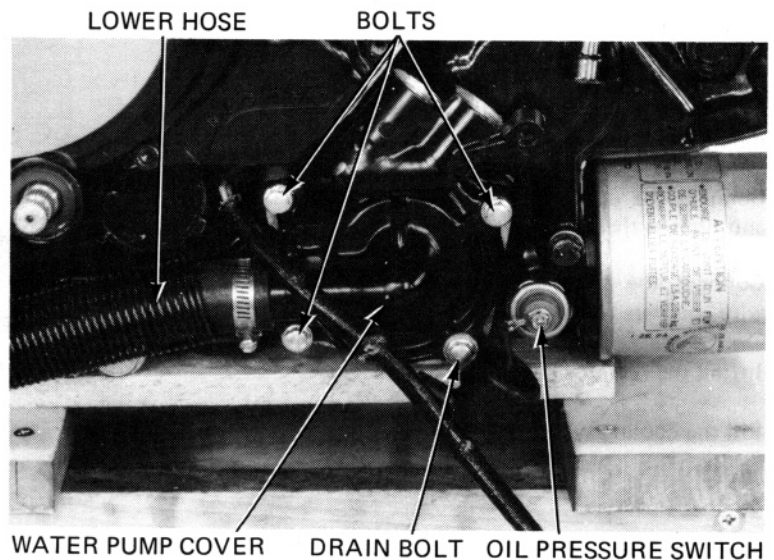
Disconnect the oil pressure switch wire.

Loosen the hose band and disconnect the radiator lower hose from the water pump.

Remove the water pump cover bolts and cover.
