GENERAL INFORMATION

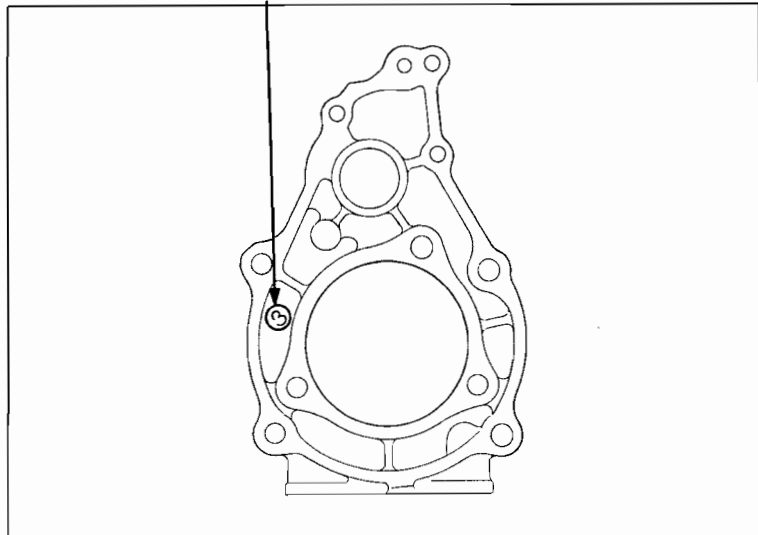
Assemble and install the countershaft (Pages 11-8 and 11-9).
