SPECIFICATIONS

IGNITION COIL

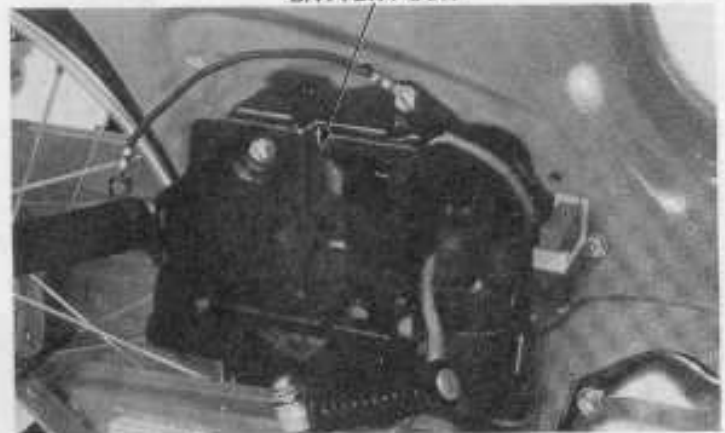
BATTERY BOX

Remove the battery box.
