WIRE HARNESS INSPECTION

CONTROL UNIT

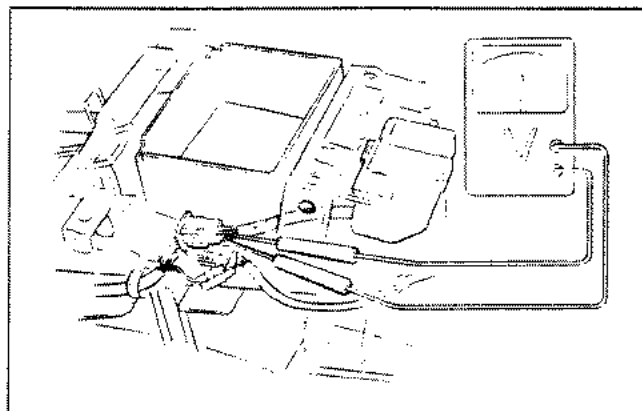
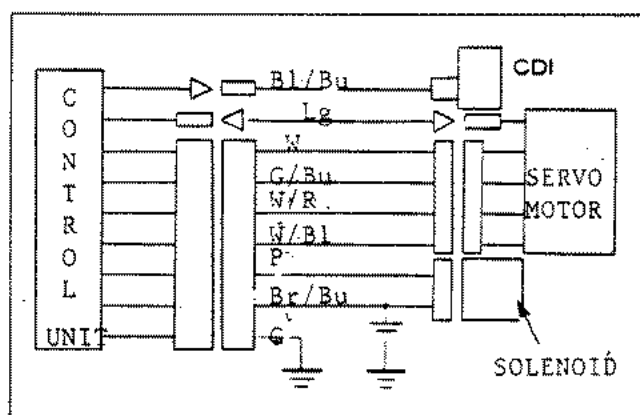
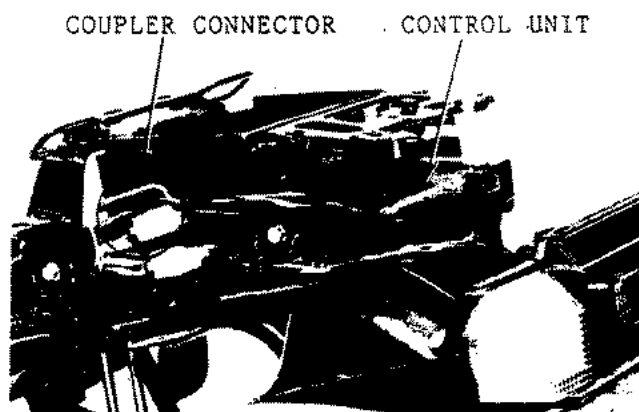
Remove control unit coupler and connectors

Pull out control unit from rear fender A shoulder and replace it.
